**Inspection Report**  
**Minerals Regulatory Program**  
May 16, 2009

<b>Mine Name:</b> Lime Peak Quarry	<b>Permit Number:</b> M/049/0047
<b>Operator Name:</b> Shaw Environmental Inc.	<b>Inspection Date:</b> June 15, 2009
<b>Inspector(s):</b> Lynn Kunzler, Emily Berry, DOGM	<b>Time:</b> 1:00 pm
<b>Other Participants:</b> Wendell Blakney, Shaw; Mark Buss, USACE, and Jeremy Ayala, HDR	<b>Mine Status:</b> Partial Reclaimed

Request by operator to evaluate reclamation of quarry portion of permit.

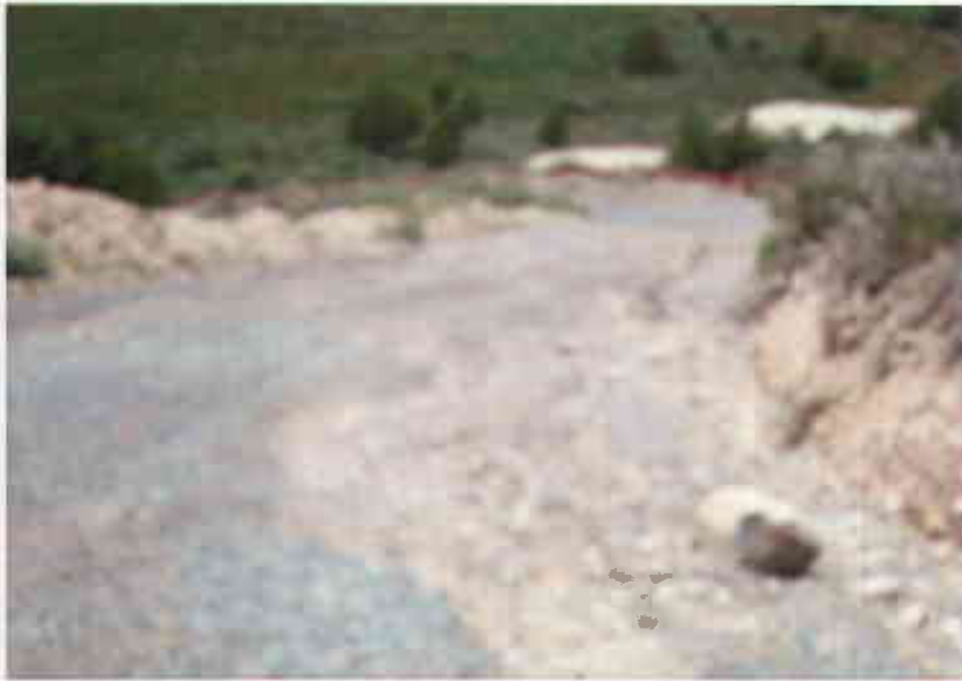
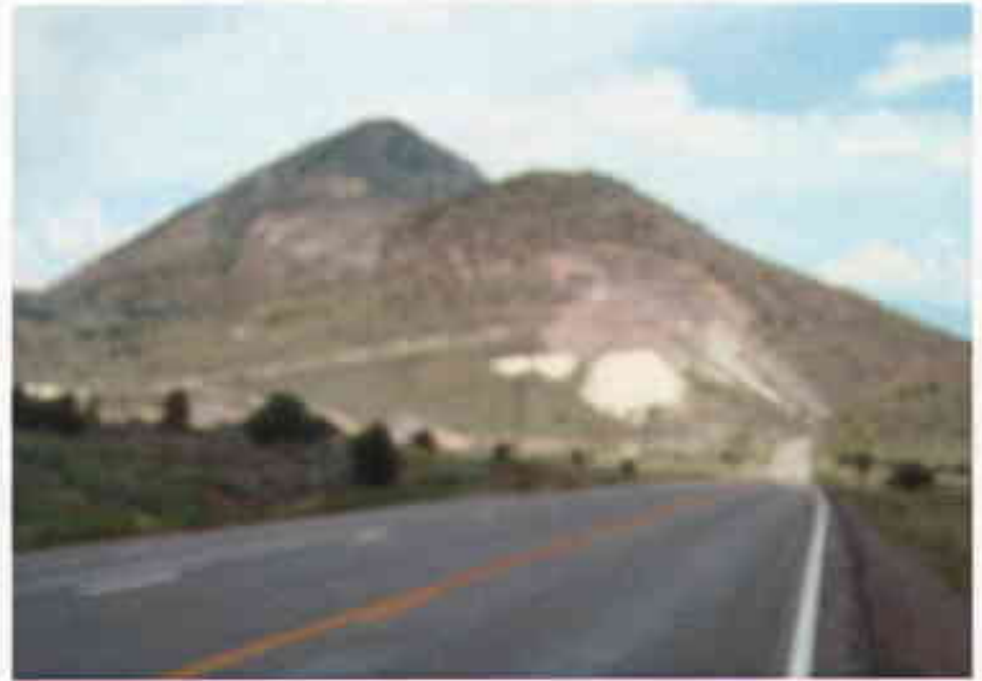
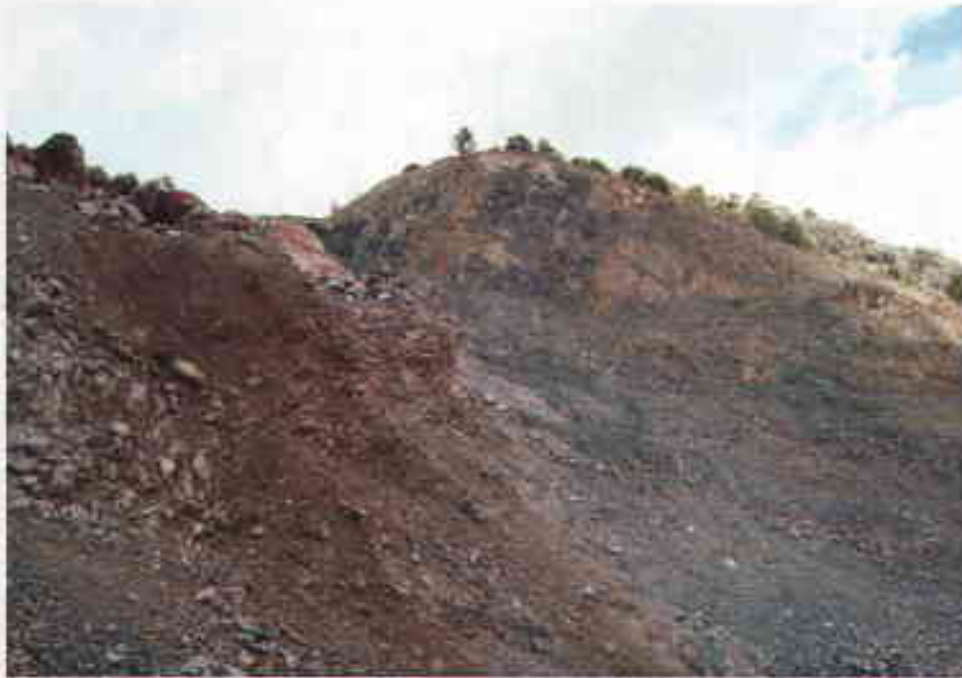
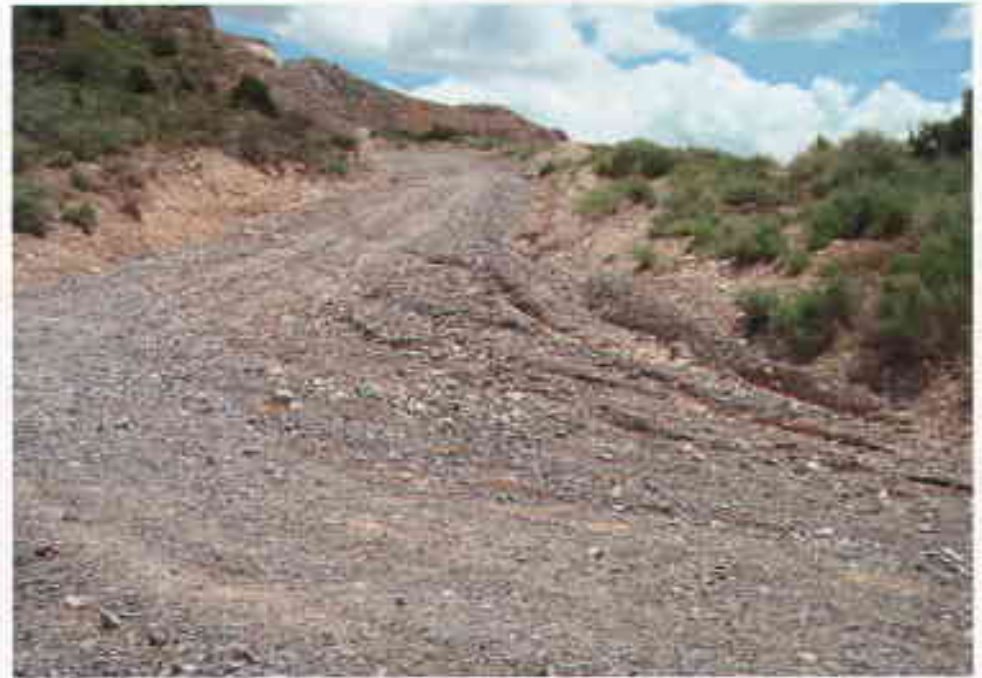
The inspection began with a short safety awareness training and an alert to watch out for snakes (several rattle snakes had been seen in the quarry area during the last few days). After the training, we proceeded to the quarry. Public is prohibited access by signage and locked gates. The regrading work has been completed at the quarry. 4 benches remain on the highwall. The highwall area, and bench interspaces were stable with no signs of erosion or instability. The pit floor was graded to a slight decline towards the highwall to contain any runoff from the area. This site had been given a variance for applying topsoil and seeding, since this was an historic quarry prior to this permitting action and there were no soil available. No vegetation existed on the site as well. It appears that the quarry area would meet the agreed to standard of stabilization for the permit.

There was one road that made a switchback to reach the top of the quarry area. This road will still need to be reclaimed by regrading to blend in with pre-existing contours and will require seeding. The main access road to the quarry shows early signs of erosion. While this road is not required to be reclaimed, it must be left in a usable condition. The company agreed to repair the minor damage and construct water bars or other erosion control structures within the next 10 days to prevent rilling in the future.

The operator will repair the road within the next 10 days and construct erosion control structures to prevent rilling in the future. If the operator no longer needs to access the quarry for additional material, the reclamation would be acceptable.
